Bubbles in Middle of Safety Laminated Glass of Polyvinyl Butyral PVB Interlayer Film

By Peter Lin

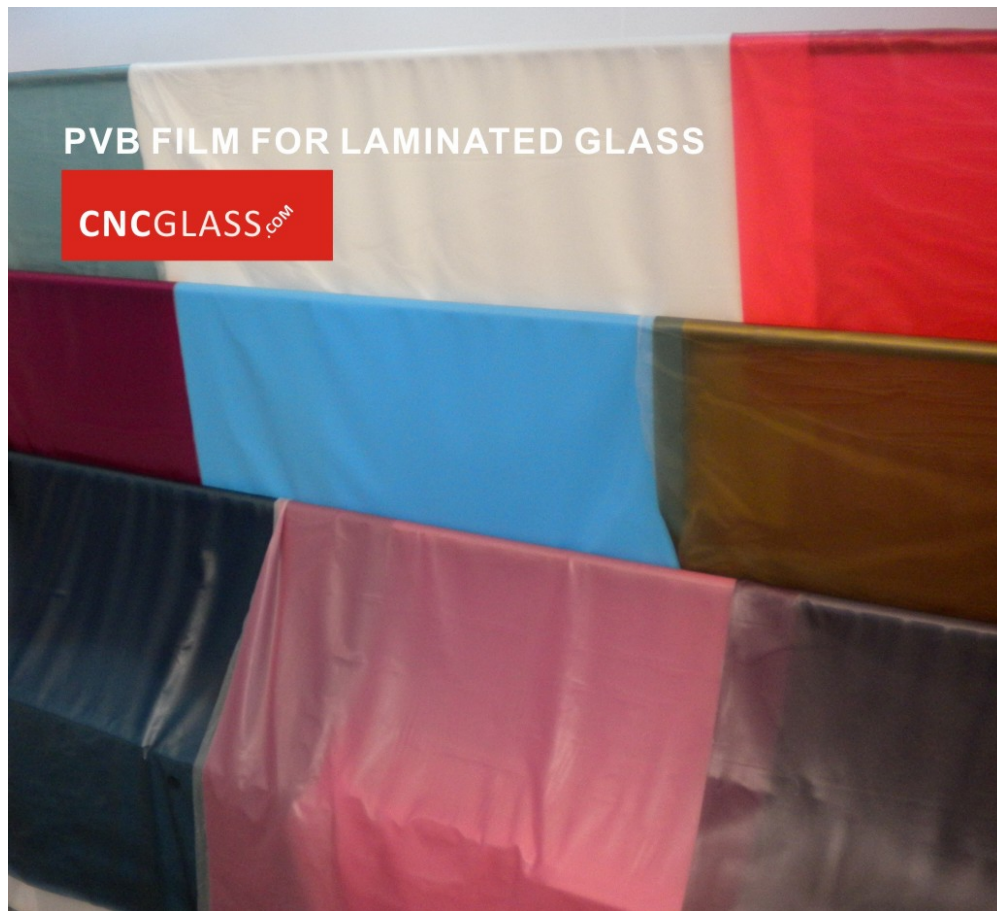
Reason Possibility 1:

In the procedure of roller exhausting air, it's too early to seal the edges of the pre-laminated glass, so the air can not be exhausted out completely in the second roller.

Reason Possibility 2:

The Polyvinyl Butyral PVB interlayer film already absorbed too much moisture.

Reason Possibility3:

The plainness of the tempered glass is not good enough.

Solution:

Adjust the speed and temperature in the pre-laminating procedure, make sure the pre-laminated glass is not sealed before the second roller exhausting air stage. Or adjust the speed of and temperature of the silicone rubber ring, to make sure the air is totally exhausted out.

Check the moisture of the Polyvinyl Butyral PVB interlayer film, and the humidity of the laminating room and glass surface.

Choose good quality tempered glass, or use thicker Polyvinyl Butyral PVB interlayer film.
