Bubbles in Middle of Safety Laminated Glass of Polyvinyl Butyral PVB Interlayer Film

By Peter Lin

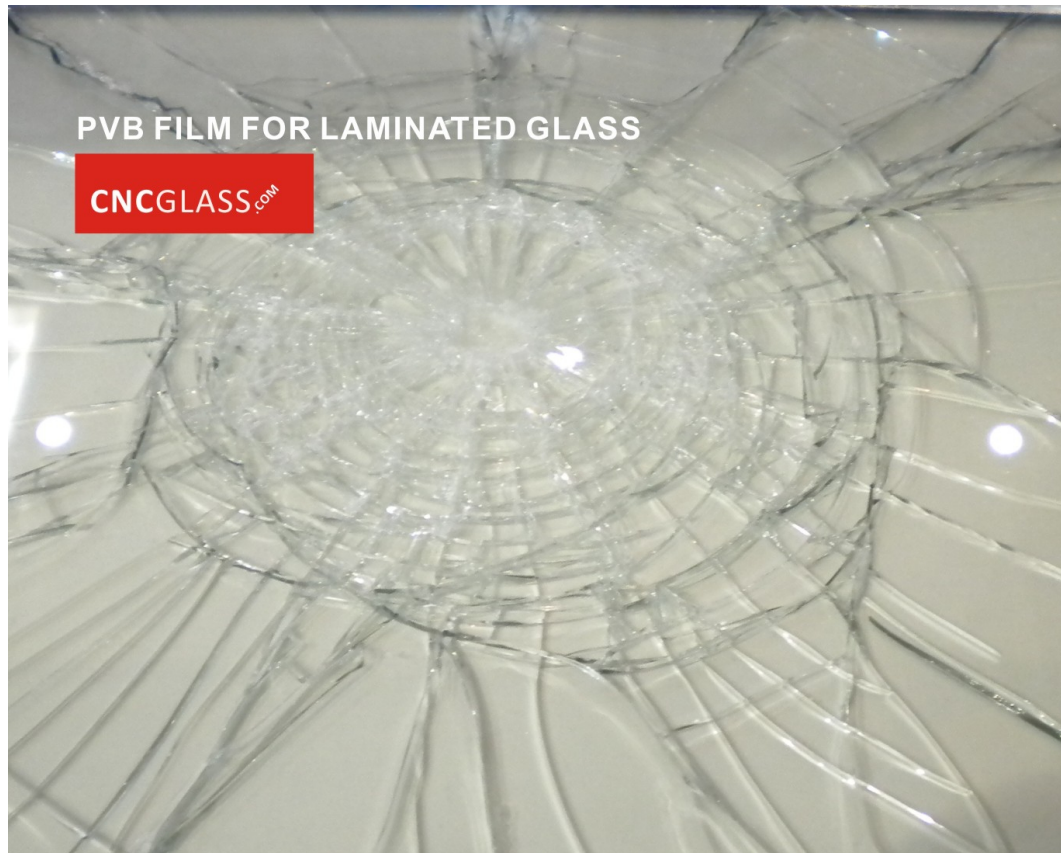
Reason Possibility 1:

In the procedure of roller exhausting air, it's too early to seal the edges of the pre-laminated glass, so the air can not be exhausted out completely in the second roller.

Reason Possibility 2:

The Polyvinyl Butyral PVB interlayer film already absorbed too much moisture.

Reason Possibility3:

The plainness of the tempered glass is not good enough.

Adjust the speed and temperature in the pre-laminating procedure, make sure the pre-laminated glass is not sealed before the second roller exhausting air stage. Or adjust the speed of and temperature of the silicone rubber ring, to make sure the air is totally exhausted out.

Check the moisture of the Polyvinyl Butyral PVB interlayer film, and the humidity of the laminating room and glass surface.

Choose good quality tempered glass, or use thicker Polyvinyl Butyral PVB interlayer film.
